# UNDERWATER FACILITIES INSPECTIONS & ASSESSMENTS

NAVAL AIR  
STATION  
NEW ORLEANS, LA.

FPO-1-85-(18)

JUNE 1985

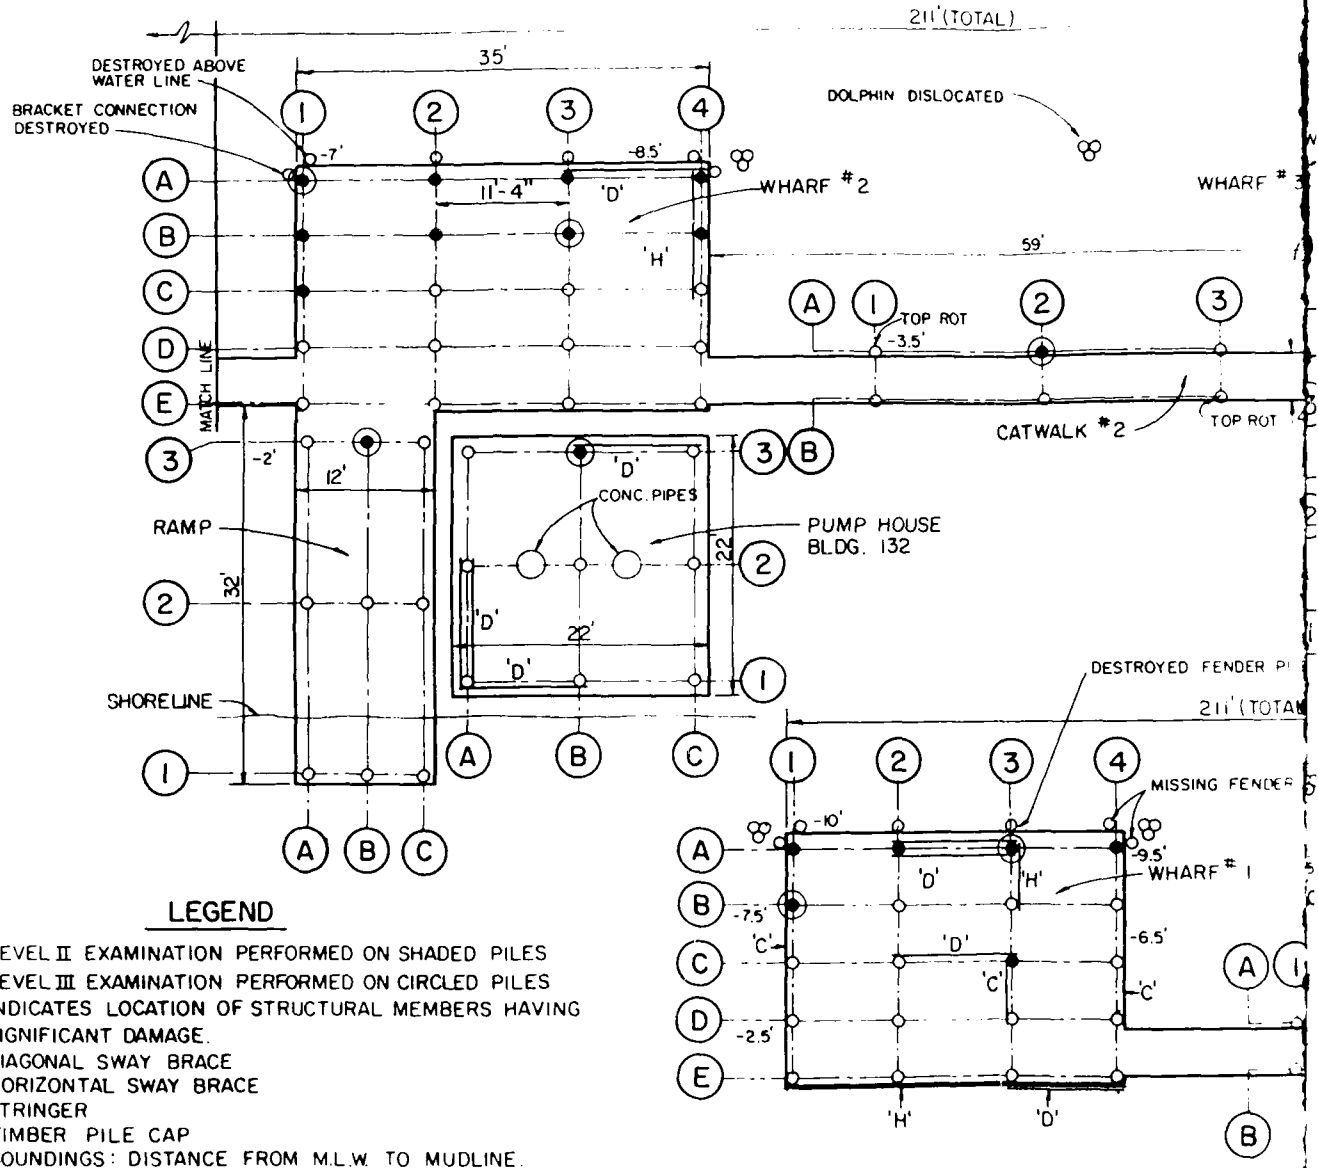
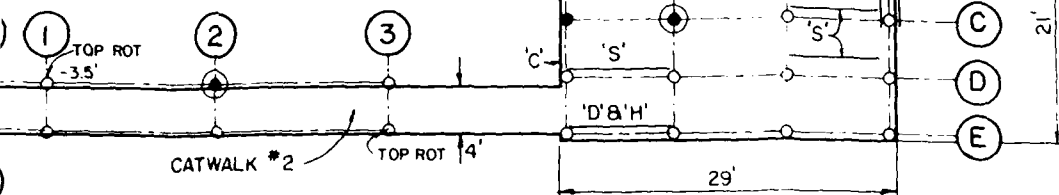
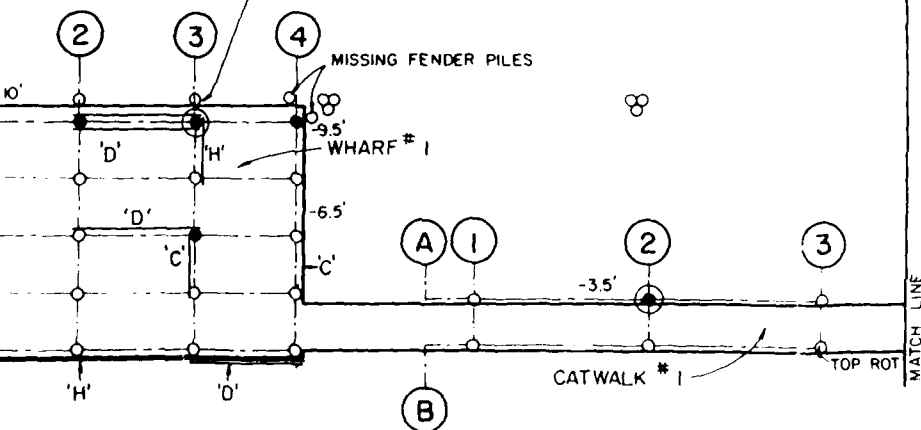
FIG NO  
3

POLYPHIN DISLOCATED

BROKEN FENDER PILES

MISSING FENDER PILE

DESTROYED FENDER PILE

MISSING FENDER PILES
